# CATALYST LOADING: A CRITICAL VARIABLE

Dan Torchia and Gavin Mcleod, Chevron Lummus Global, USA, and Paul Cannatella and Greg Scott, Valero, USA, analyse the impact of proper catalyst loading on hydrocracker performance.

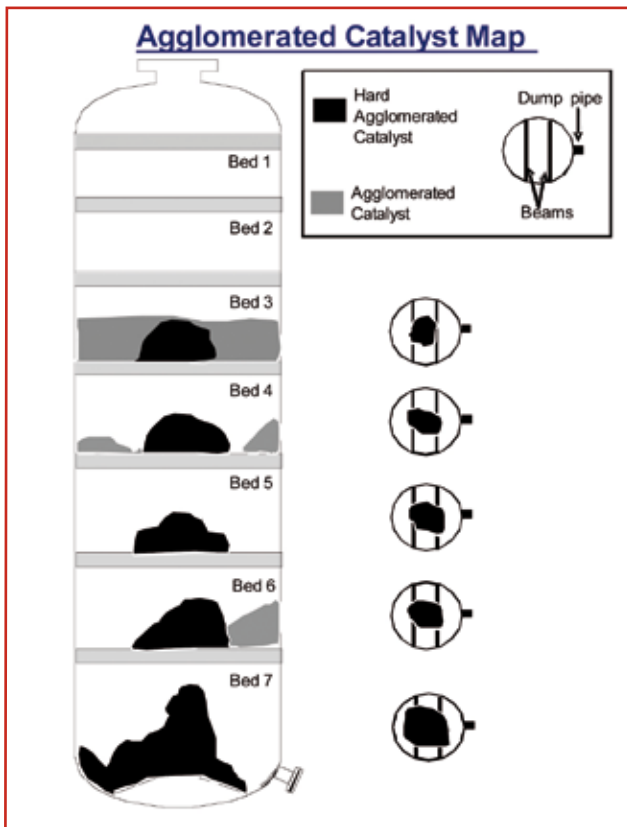
Figure 1. Agglomerated catalyst map.

CLG kept detailed records in the form of video, digital photos, and written documentation throughout the reactor turnaround. The catalyst unloading contractors were required to keep very detailed records of the condition of the reactors throughout the entire unloading process to determine the exact cause of the apparent channeling and maldistribution witnessed during Run 2. Diagrams were made at the end of each shift by the unloading contractors in conjunction with CLG personnel. After careful examination of these records it was determined that the primary cause of the problems in Run 2 was inconsistent loaded densities throughout most of the reactor; predominantly in Beds 3 and 4, where the highest radials were observed during Run 2. This was concluded based on inconsistent catalyst conditions observed while unloading. These inconsistent densities were attributed to improper dense loading, as illustrated in Figure 1.

To prevent a recurrence of Run 2 problems, strict criteria were set for the cleaning, inspection and reload of the reactors. Detailed checklists were developed specific to each bed of both reactors. After unloading was complete, the

As with the cleaning and inspections, detailed loading checklists and loading diagrams were developed and discussed with all parties involved in the loading procedure. Manpower for the loading activity was discussed and agreed upon. Catalyst was spotted onsite. The supersacks were marked with fluorescent paint to identify the catalyst type and sack count. Plans for the frequency of density checks were made and agreed upon. Contingency plans were made in the case of abnormal situations. Catalyst retain samples were taken. The catalyst was field tested to verify previously targeted loading densities. HPA used a laser level for accurate markings on the reactor walls for expected levels of support media and catalyst. The bed thermocouples were mapped out with positions/heights recorded. The Hydropac dense loading machine was selected for use based on its unique design, which provides an even distribution of catalyst to the cross-sectional area of the bed. Due to the machine's design (it sits below the distributor tray) the beds could be

dense loaded to their maximum potential. Utilising state of the art hardware and expertise, CLG was able to avoid the shadow effect (that can occur at reactor obstructions such as internal dumps pipes), which can lead to maldistribution and channelling. Catalyst loading proceeded smoothly and was completed on schedule even during some periods of light rain.

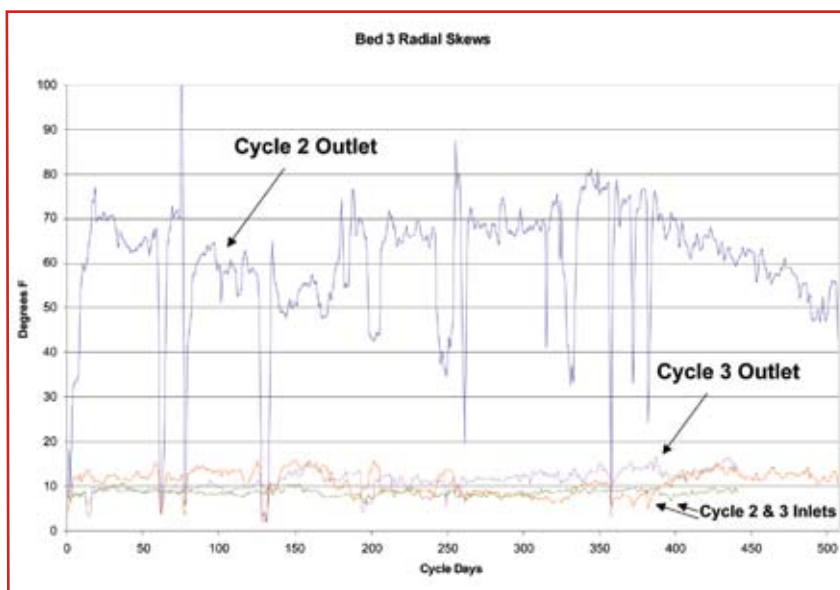
Figure 2. Comparison of Cycles 2 and 3.

Startup procedures were reviewed and modified to help ensure proper catalyst wetting and sulfiding. Detailed records of all aspects of the startup were kept for review and troubleshooting in the event of unexpected occurrences. The startup proceeded smoothly and the unit was brought online without incident. Unit data at startup showed significant improvement in reactor performance. Catalyst bed thermocouples showed even distribution throughout the beds with no signs of channelling, as illustrated in Figure 2, which compares the two cycles.
